GEO-ENVIRONMENTAL SUMMARY – MILTON HILL, CLAPHAM

Wardell Armstrong LLP (WA) was commissioned to undertake a Geo-environmental Assessment to support the promotion of a new housing development within the Neighbourhood Development Plan, for a site at Milton Hill, Clapham, Bedfordshire. This document provides a summary of the works undertaken and an overview of the findings and recommendations from the assessment.

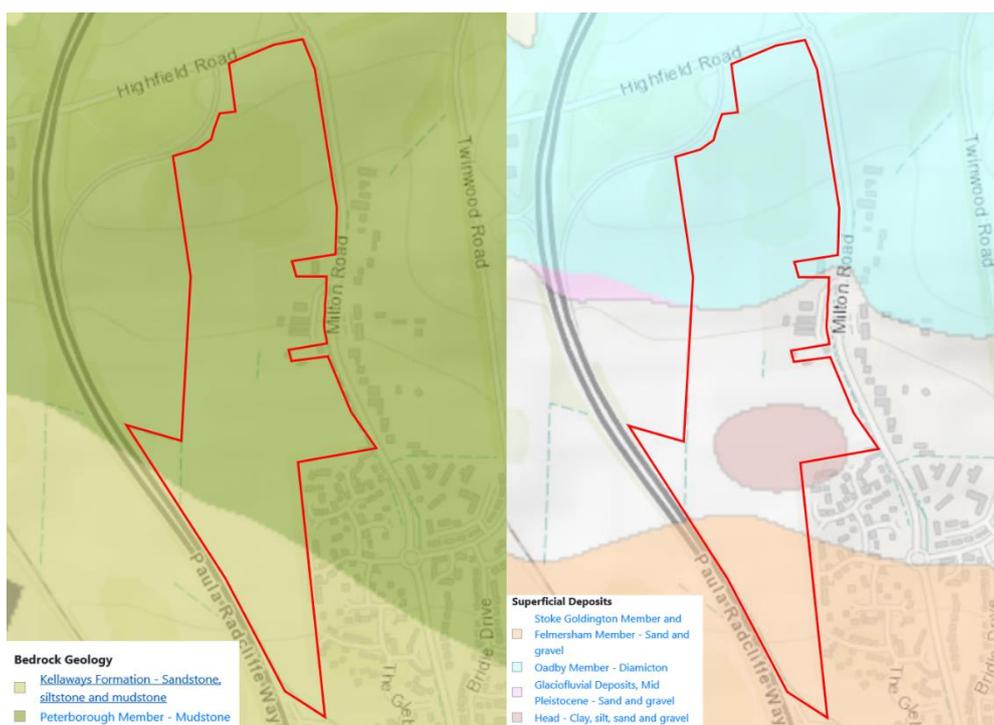
Figure 1: Bedrock Geology (Left) and Superficial Deposits (Right) underlying the Site

Geological mapping (see Figure 1 overleaf) indicates that the Site is mainly overlain by the following superficial deposits:
